August 26, 2022

**Tree Protection & Plan Review** Toronto and East York District 50 Booth Ave, Booth Yard. Toronto, ON M4M 2M2 T (416) 392-7391 E tpprsouth@toronto.ca **17 Elm GP Inc.** c/o: lyle@foradevelopments.com 17 Elm Street Toronto, ON M5G 1H1 T (416) 464 4322 E lyle@foradevelopments.com

Re: 17 Elm St (Ward 11)

# Arborist Report

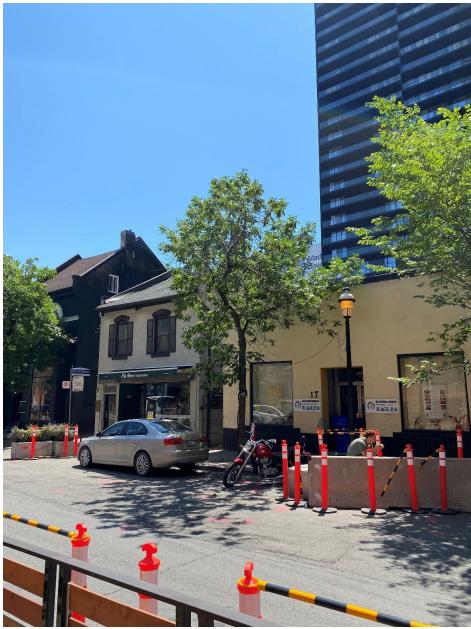
Figure 3: Tree 1 (facing southeast).

#	Species	Latin Name	DBH (cm)	TPZ (m)	Health	Structure	Assessment	Comment	Category
1	Green ash	Fraxinus pennsylvanica	21	1.8	Fair Poor	Fair	Sparse canopy. Codominant 2m. Deadwood throughout canopy. Epicormic growth throughout canopy. Electrical wire and lights in mainstem and canopy.	Permit to remove	5
2	Elm	Ulmus spp.	16	1.8	Fair	Fair Poor	Multi-stem 2m with included unions. Moderately sparse canopy. Epicormic throughout canopy. Electrical wire and lights in mainstem and canopy. Deadwood throughout canopy including large limb ~10cm dia.	Permit to remove	5
3	Green ash	Fraxinus pennsylvanica	26.5	1.8	Fair	Fair	Moderately sparse canopy. Codominant 2.5m with included union. Electrical wire and lights around mainstem and canopy. Epicormic growth present throughout. Minor deadwood present throughout. Decay present near main union with reaction wood present, unlikely to seal fully.	Permit to remove	5

**City owned Trees 1** (21cm DBH Green Ash), **2** (16cm DBH Elm) and **3** (26cm DBH Green Ash) will require **permits to remove** to facilitate site access, utility servicing and the landscape plan.

Tree 1 was determined to have a basic reproduction cost of \$2450.00.

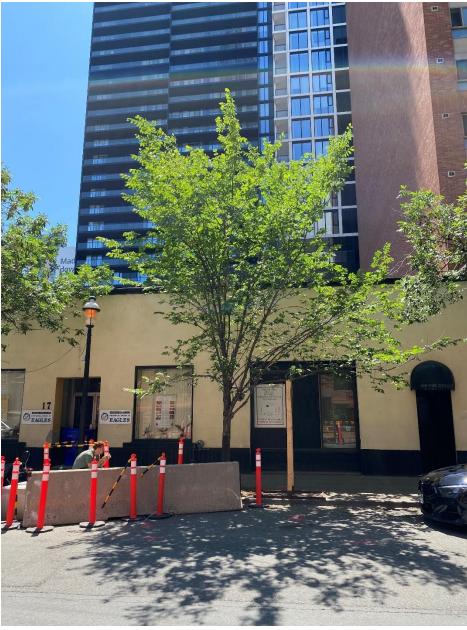
Figure 4: Tree 2 (facing south).

Tree 2 was determined to have a basic reproduction cost of \$1380.00.

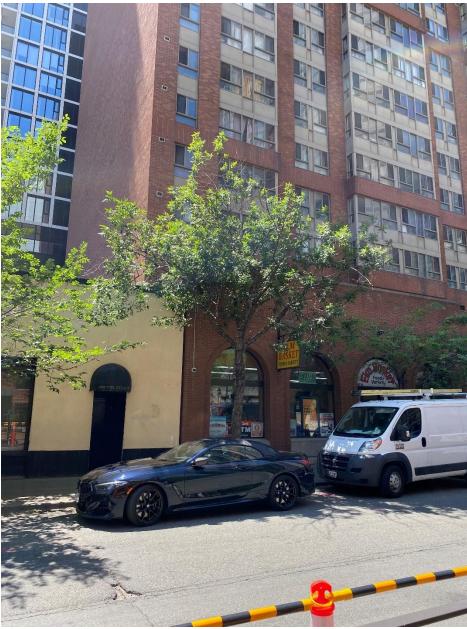
Figure 5: Tree 3 (facing southwest).

Tree 3 was determined to have a basic reproduction cost of \$3900.00.

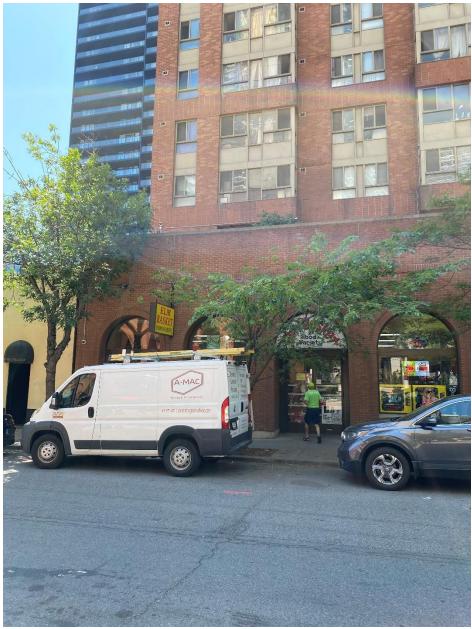
Figure 6: Trees 3 and 4 (facing south).

4	Elm	Ulmus spp.	13	1.8	Fair Poor	Poor	Sparse canopy overall, significant epicormic growth throughout canopy. Previously Codominant 2.5m with failure at union, limited to no reaction wood present. Canopy dieback present, small deadwood present throughout	Fully Protect	5
5*	Green ash	Fraxinus pennsylvanica	26	1.8	Fair	Fair	Moderately sparse canopy. Epicormic growth throughout. Small deadwood present. Codominant 3m. Decay present near union with reaction wood present. Electrical wires around stem.	Permit to injure	5

Due to the presence of existing sidewalks and hardscape surrounding Trees 4 and 5, tree protection hoarding is recommended for installation along the planting bed around each tree to avoid disrupting pedestrian traffic. No tree protection hoarding is proposed for Tree 6 as the tree is sufficiently far enough away from the proposed development.

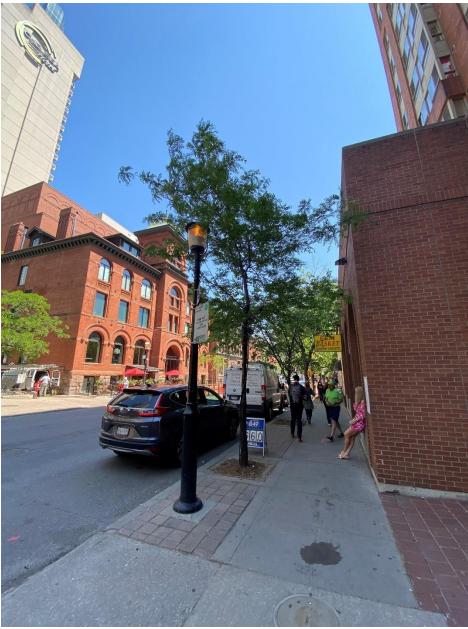
Figure 7: Tree 5 (facing northeast).

Excavation associated with the proposed landscape plan is expected to occur as close as 1.40m's to the base of **City owned Tree 5** (26cm DBH Green Ash). Due to the presence of the existing hardscape surrounding Tree 5, significant roots from the tree are not expected to be encountered within the limit of work and impact from the excavation is expected to be within the tolerance range of tree 5. To minimize impact to Tree 5, the following recommendations shall be adhered throughout construction:

- Excavation within the TPZ of a protected tree shall follow the details outlined below in the "Recommendations for Excavation within a TPZ" section below.
- Excavation within the TPZ of a protected tree shall be performed using hand tools, air spade of hydro-vac wherever possible, under the supervision of a qualified arborist.
- Roots impacted during the excavation shall be pruned by the supervising arborist following the latest arboricultural standards
- Limestone subbase material is not recommended for used during construction within the TPZ of a protected tree as it can affect soil pH, instead an inert material such as high-performance bedding (HPB) is recommended for use.

A **permit to injure** Tree 5 is requested to facilitate the proposed development.

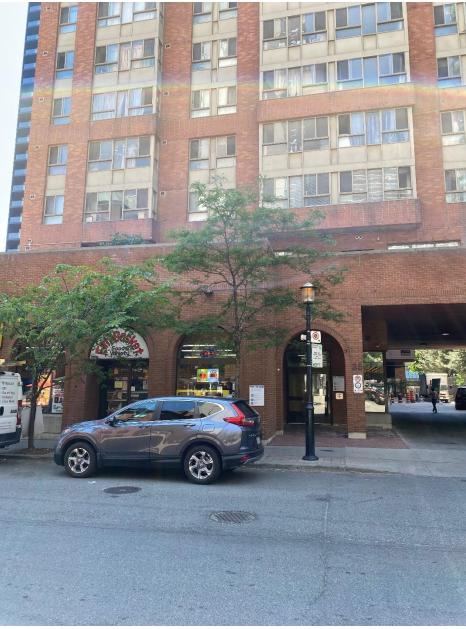
Figure 8: Tree 6 (facing south).

#	Species	Latin Name	DBH (cm)	TPZ (m)	Health	Structure	Assessment	Comment	Category
6*	Honey Locust	Gleditsia triacanthos	11	1.8	Fair Good	Fair	Some Epicormic growth present, some dieback present. Minor deadwood present. Canopy growing on lean towards road. Asymmetrical canopy.	Fully Protect	5
